PHOTOGRAPHIC INTERPRETATION MEMORANDUM

POSSIBLE OIL DRILLING OPERATION IN NORTH VIETNAM

NPIC/R-136/68 DECEMBER 1968

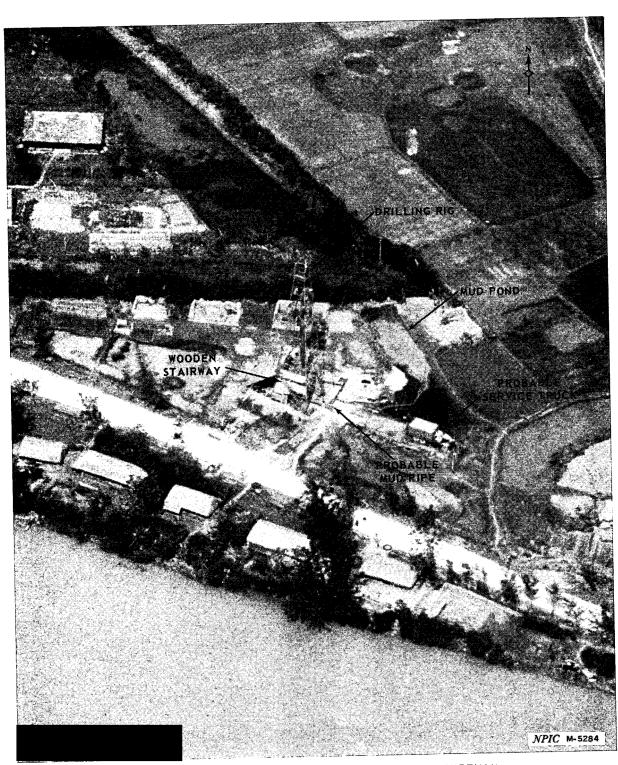
A possible exploratory oil drilling operation first observed in North Vietnam in has again been observed on low-level photography of 4.1 nautical miles (nm) southeast of Thai Binh and 33 nm southwest of Haiphong. The large drilling rig (Figure 1) has a large lean-to shed attached to the west side, which may house a generator. A probable mud pipe extends from the rig to an adjacent mud pond.

Large stacks of piping, normally associated with oil drilling, are not in evidence at the site. On the coverage, a few lengths of possible pipe are standing upright within the framework of the rig, and on the later photography at least seven pipe sections are lying on the ground in front of the rig. Latest coverage of the facility indicates that several buildings have been removed and some of the previously observed small structures in the area have been repaired.

FIGURE 1. DRILLING SITE, THAI BINH AREA, NORTH VIETNAM.

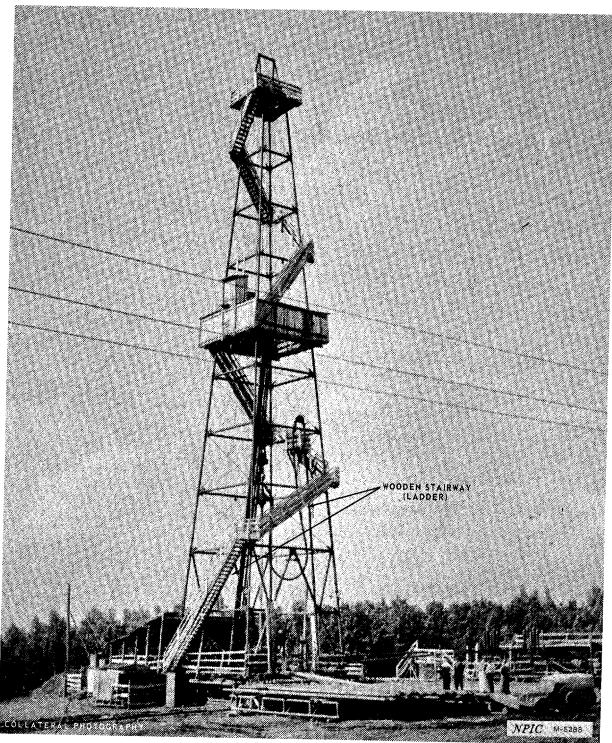
The operation may be in search of crude oil deposits in the Tonkin Delta area, although no refining capability is known to exist in North Vietnam. A small portable drilling rig, observed in Haiphong on photography of could have been used in obtaining core samples or in actual drilling for oil or gas. Figure 2 is an exploratory oil drill-ance to the drilling rig observed in North Vietnam.

FIGURE 2. EXPLORATORY OIL DRILLING RIG, TUYMAZY-OKTYABRSK OILFIELDS, USSR.
